TALIESIN

Taliesin Residence Preservation Projects

Taliesin Guest Wing

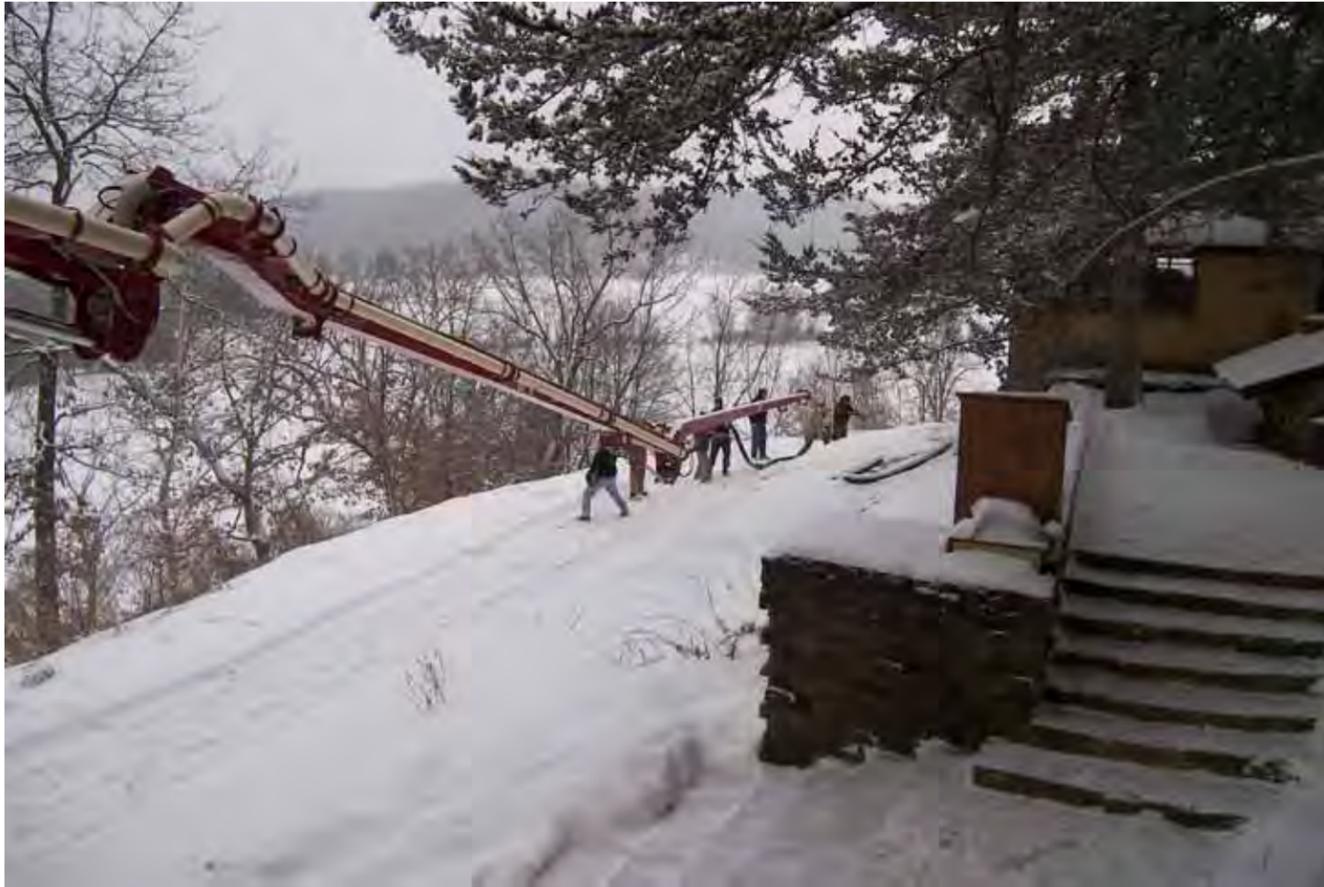
A concrete pumping truck is used to deliver concrete into the Guest Wing.

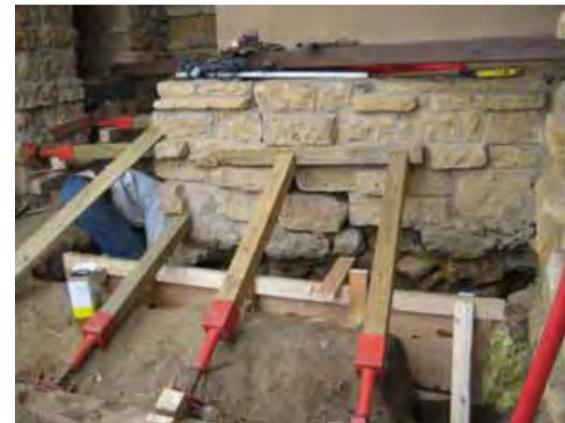
One of the stone walls that is failing due to lateral forces.

The purpose of this project is to underpin and repair the Guest Wing foundations walls, which were constructed over stone rubble. These so-called Welsh footings have served well over time; however, they are unable to resist the lateral forces that are pushing the exterior walls down the hillside. Work performed includes: underpinning the foundations; the creation of small pilings to tie the foundation walls into the bedrock of the hill; and the creation of lateral grade beams to tie into the interior and exterior stone walls in order to stabilize them laterally.

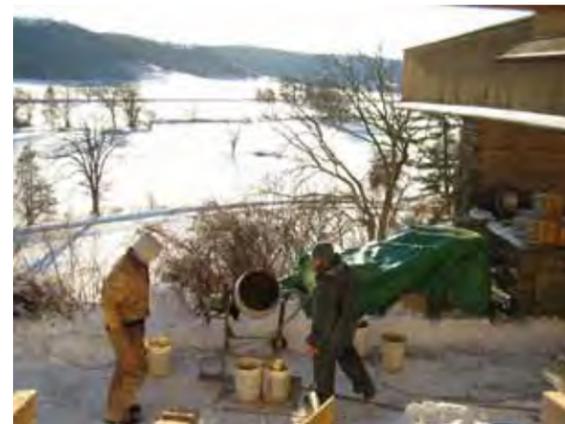
Hand mixing was necessary so that as sections underneath walls were excavated they could be filled.

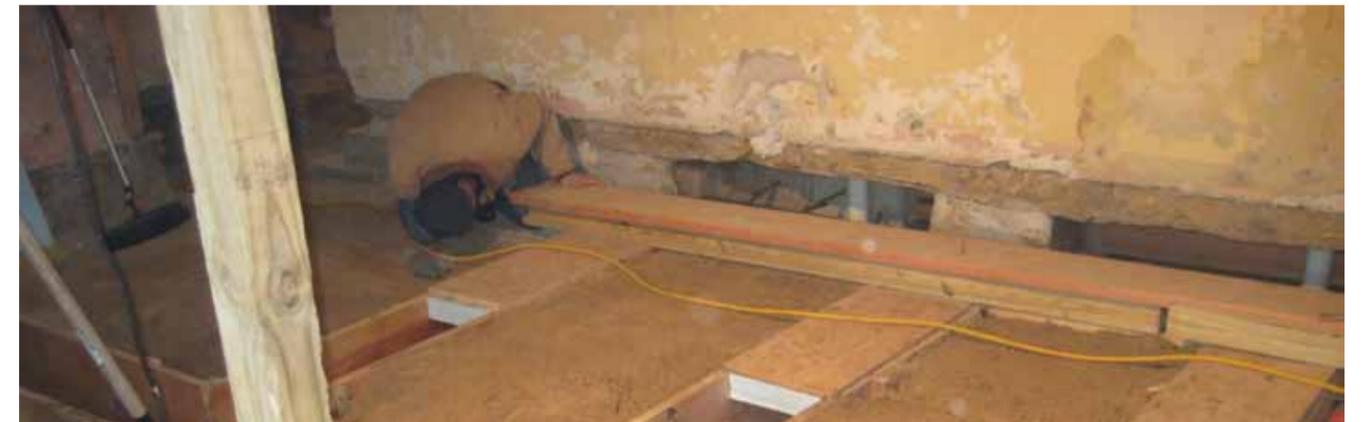
Wall excavated with needle beams- the gaps were filled with concrete to provide a continuous footing.

Underpinning was carried out with the use of needle beams, where sections of walls are excavated and given new footings. After these sections are poured the remaining gaps are filled in to create a continuous foundation. The concrete pilings were formed by drilling nine-inch diameter holes into the underlying bedrock on both sides of the foundation, installing steel reinforcing, and then filling the holes with concrete. Grade beams were installed both adjacent to the exterior walls to provide lateral stability and also between walls at 90 degrees to the hill slope in order to tie interior and exterior walls together. The underpinning, grade beams and pilings, including the steel reinforcing, were tied together for stability. Most of this work has been completed and the Preservation Team is about to move to the next phase, as described below.

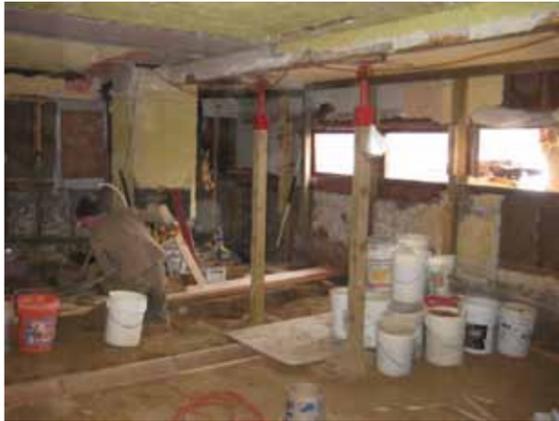
Room #5, located underneath the Living Room, team members had to hand dig grade beam trenches and move earth out with 5 gallon buckets.

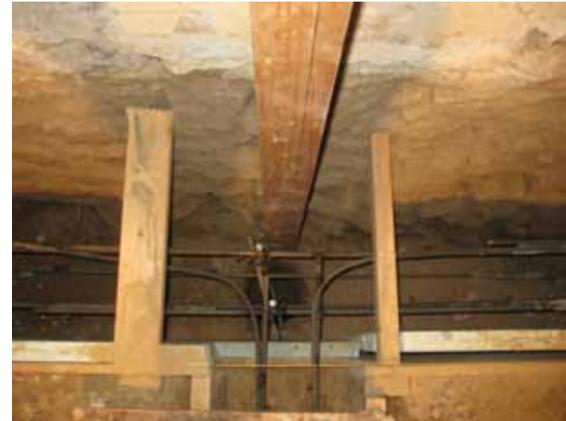
Detail of rebar connection between grade beam and pier.

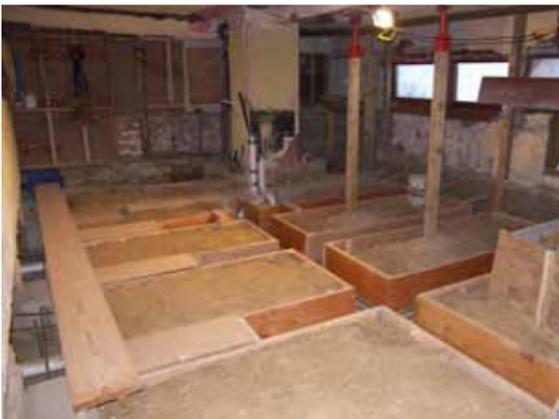
Same room as above with trenches completed, these were poured continuously using a concrete pump truck.

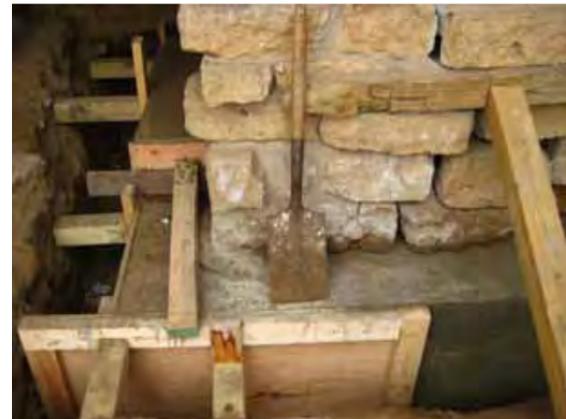
Underpinning at the stone foundation under Mr. Wright's Bedroom.

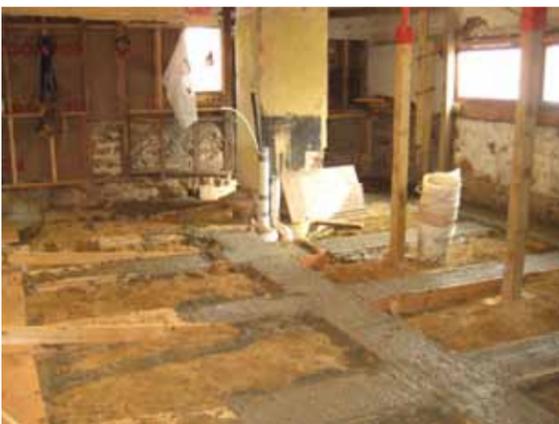
After concrete has been poured

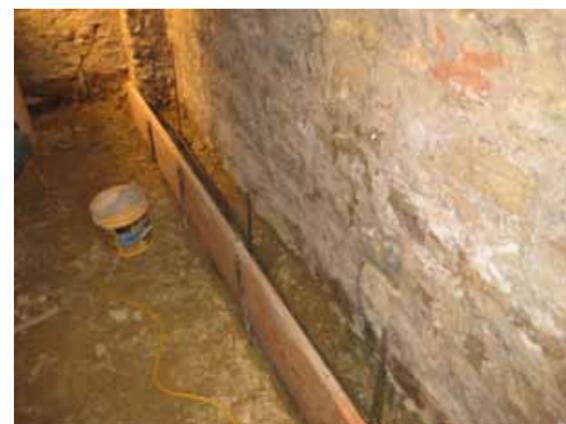
Trench in the boiler room ready for concrete to be poured.

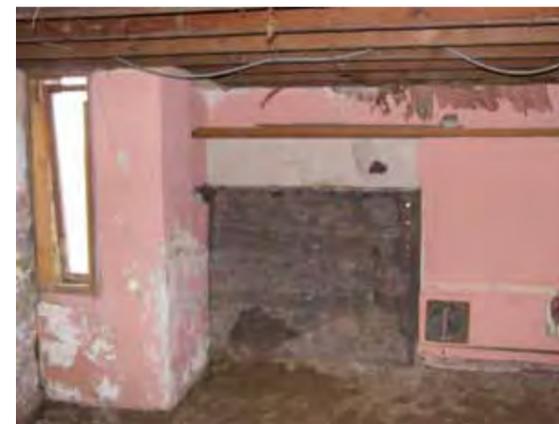
North interior elevation of room #4 with finishes and floor removed.

As a necessary part of this project, interior finishes, much of which had either been damaged by moisture, structural movement, or alteration, were removed, along with the concrete floors. This gave the Preservation Team an opportunity to plan for the next phases: the replacement of the original single pipe radiator system with updated Heating, Venting and Cooling systems for the Guest Wing and the routing of the necessary piping to update the HVAC in the two levels above the Guest Wing. After the mechanical, electrical, and plumbing work is completed, the historic finishes will be restored, based on physical and photographic evidence.

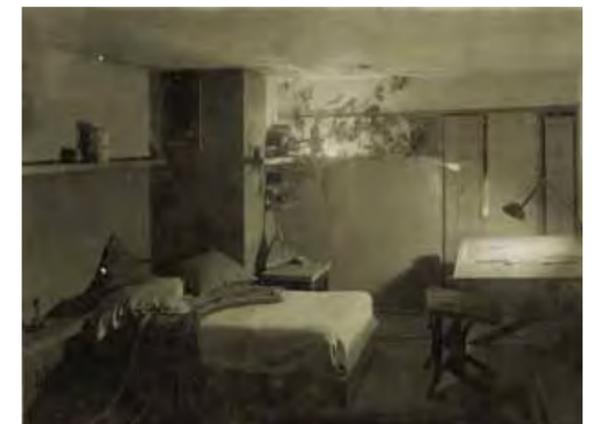
North interior elevation historic photo, this will be used to guide the restoration of this room. Photo courtesy of the Frank Lloyd Wright Foundation.
